Alky- V-1440 ESP Failure

IMPACT ERM
Loss ID# 38106

Location:
Alky Plant
Cracking Division

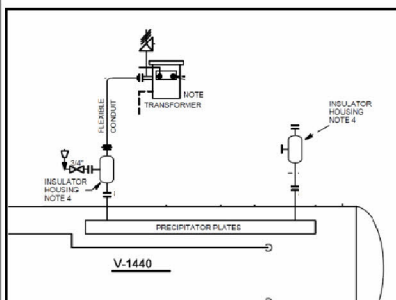
P&ID of V-1440 and the insulator housing

- 3) The insulators are located in the insulator housing that has a flush source. The equipment manufacturer recommends a constant clean flush to the insulator housing to avoid insulator failures. Our current system has shown a loss in flush for nearly 40 hours in 2011. This can lead to premature insulator failures over time.

- 1) Work with the Best Practice team to change the procedures so that the requirement to replace the insulators every 5 years is clearly written in the ESP Best Practice document.
- 2) Issue new S/D PMs so that the insulators are replaced every 5 years during a Major Turnaround.
- 3) Perform a thorough design review of the flush system to make enhancements to reliability of the flush to the insulator housing.

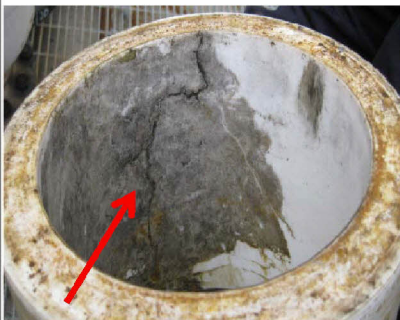
Image of failed insulator. Tracking indications can be seen.

- 1) Upon inspection, it was found that one of the two insulators (which protect the conductors that provide electrical charge to the ESP grid) had failed as a result of tracking.

- 2) The insulators were nearly 12 years old at the time of failure and were being routinely inspected every turnaround per the equipment manufacturer recommendations and guidance.

- 1) Current Chevron Best Practices recommend replacing the insulators every 5 years. However, the investigation team found this recommendation was not clearly detailed anywhere and was not included in S/D events.

- 4) In the 2000 Alky S/D, tracking indications were found requiring the insulators to be replaced after 5 years of operation. The equipment manufacturer had reported the insulators can last up to 15 years with proper flush. The indications found were a result of impurities or lack of flush. However, it appears that this recommendation from the OEM was never acted upon, implemented or investigated further.
